**Town of Summerville
Tree Protection Board Meeting
June 8, 2020 – 9:00 am
Town Hall, Town Council Chambers**

STAFF REPORT
Tree Protection Committee Meeting
June 1, 2020

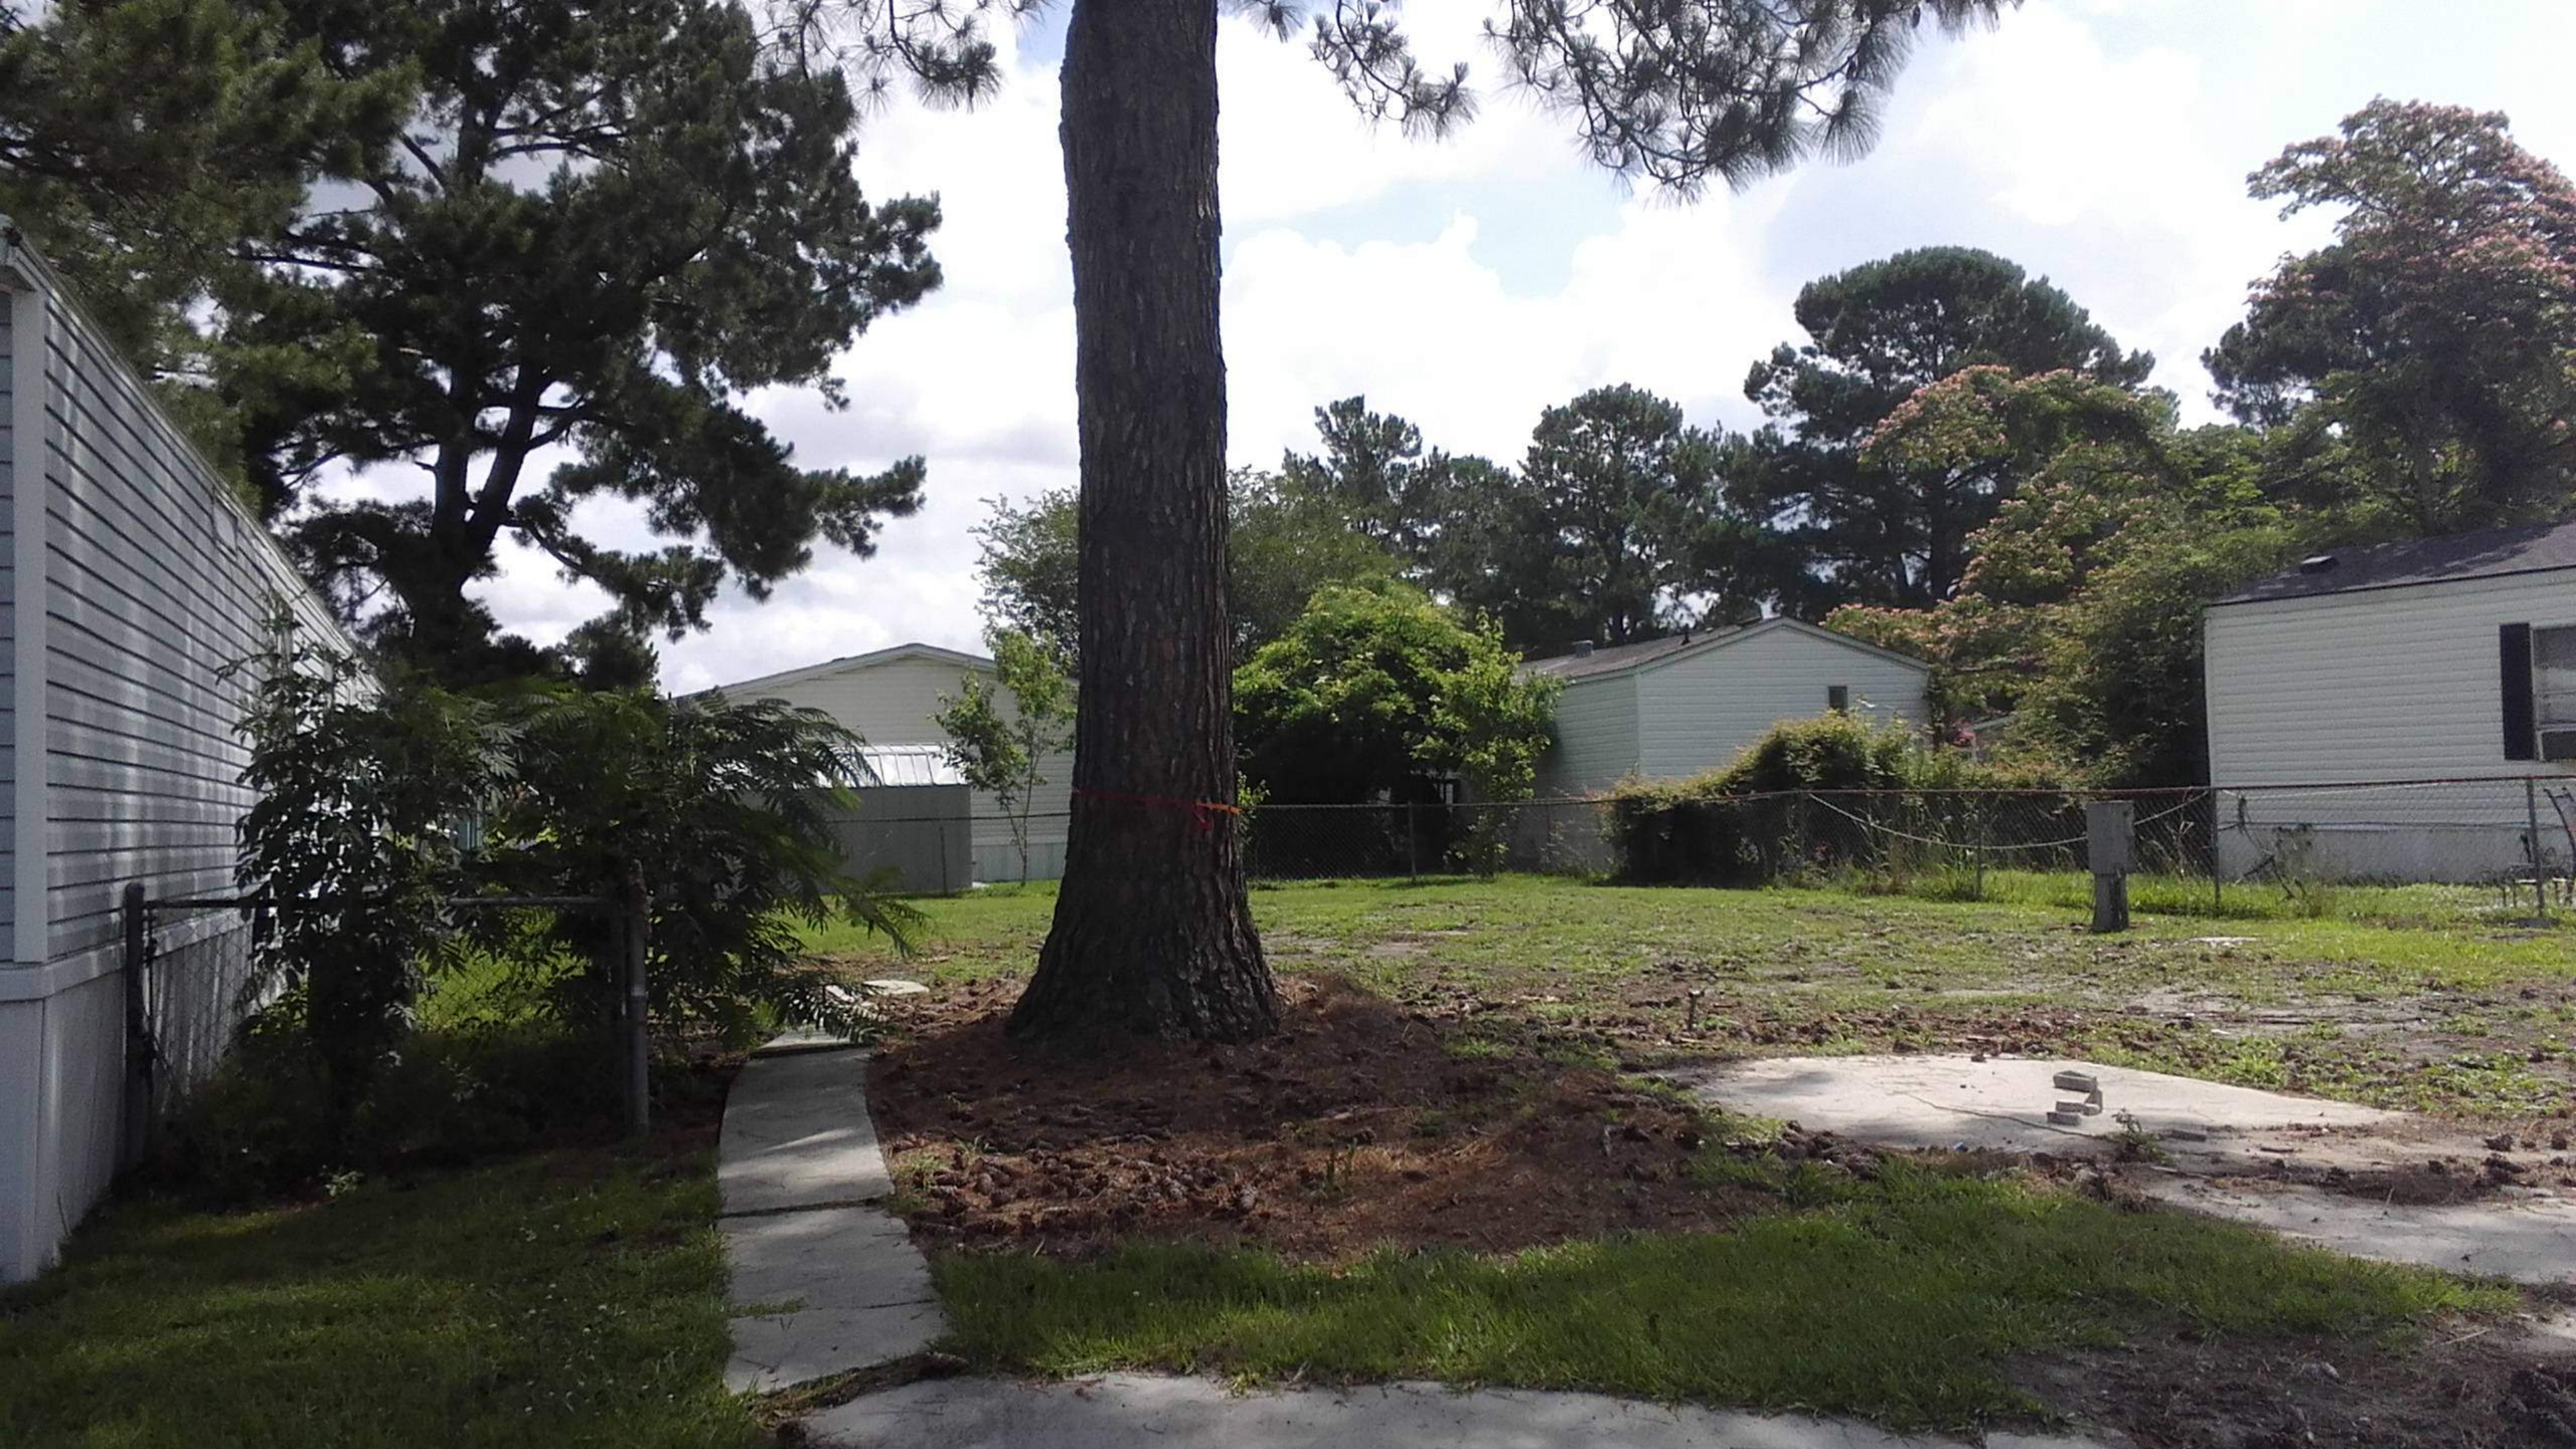
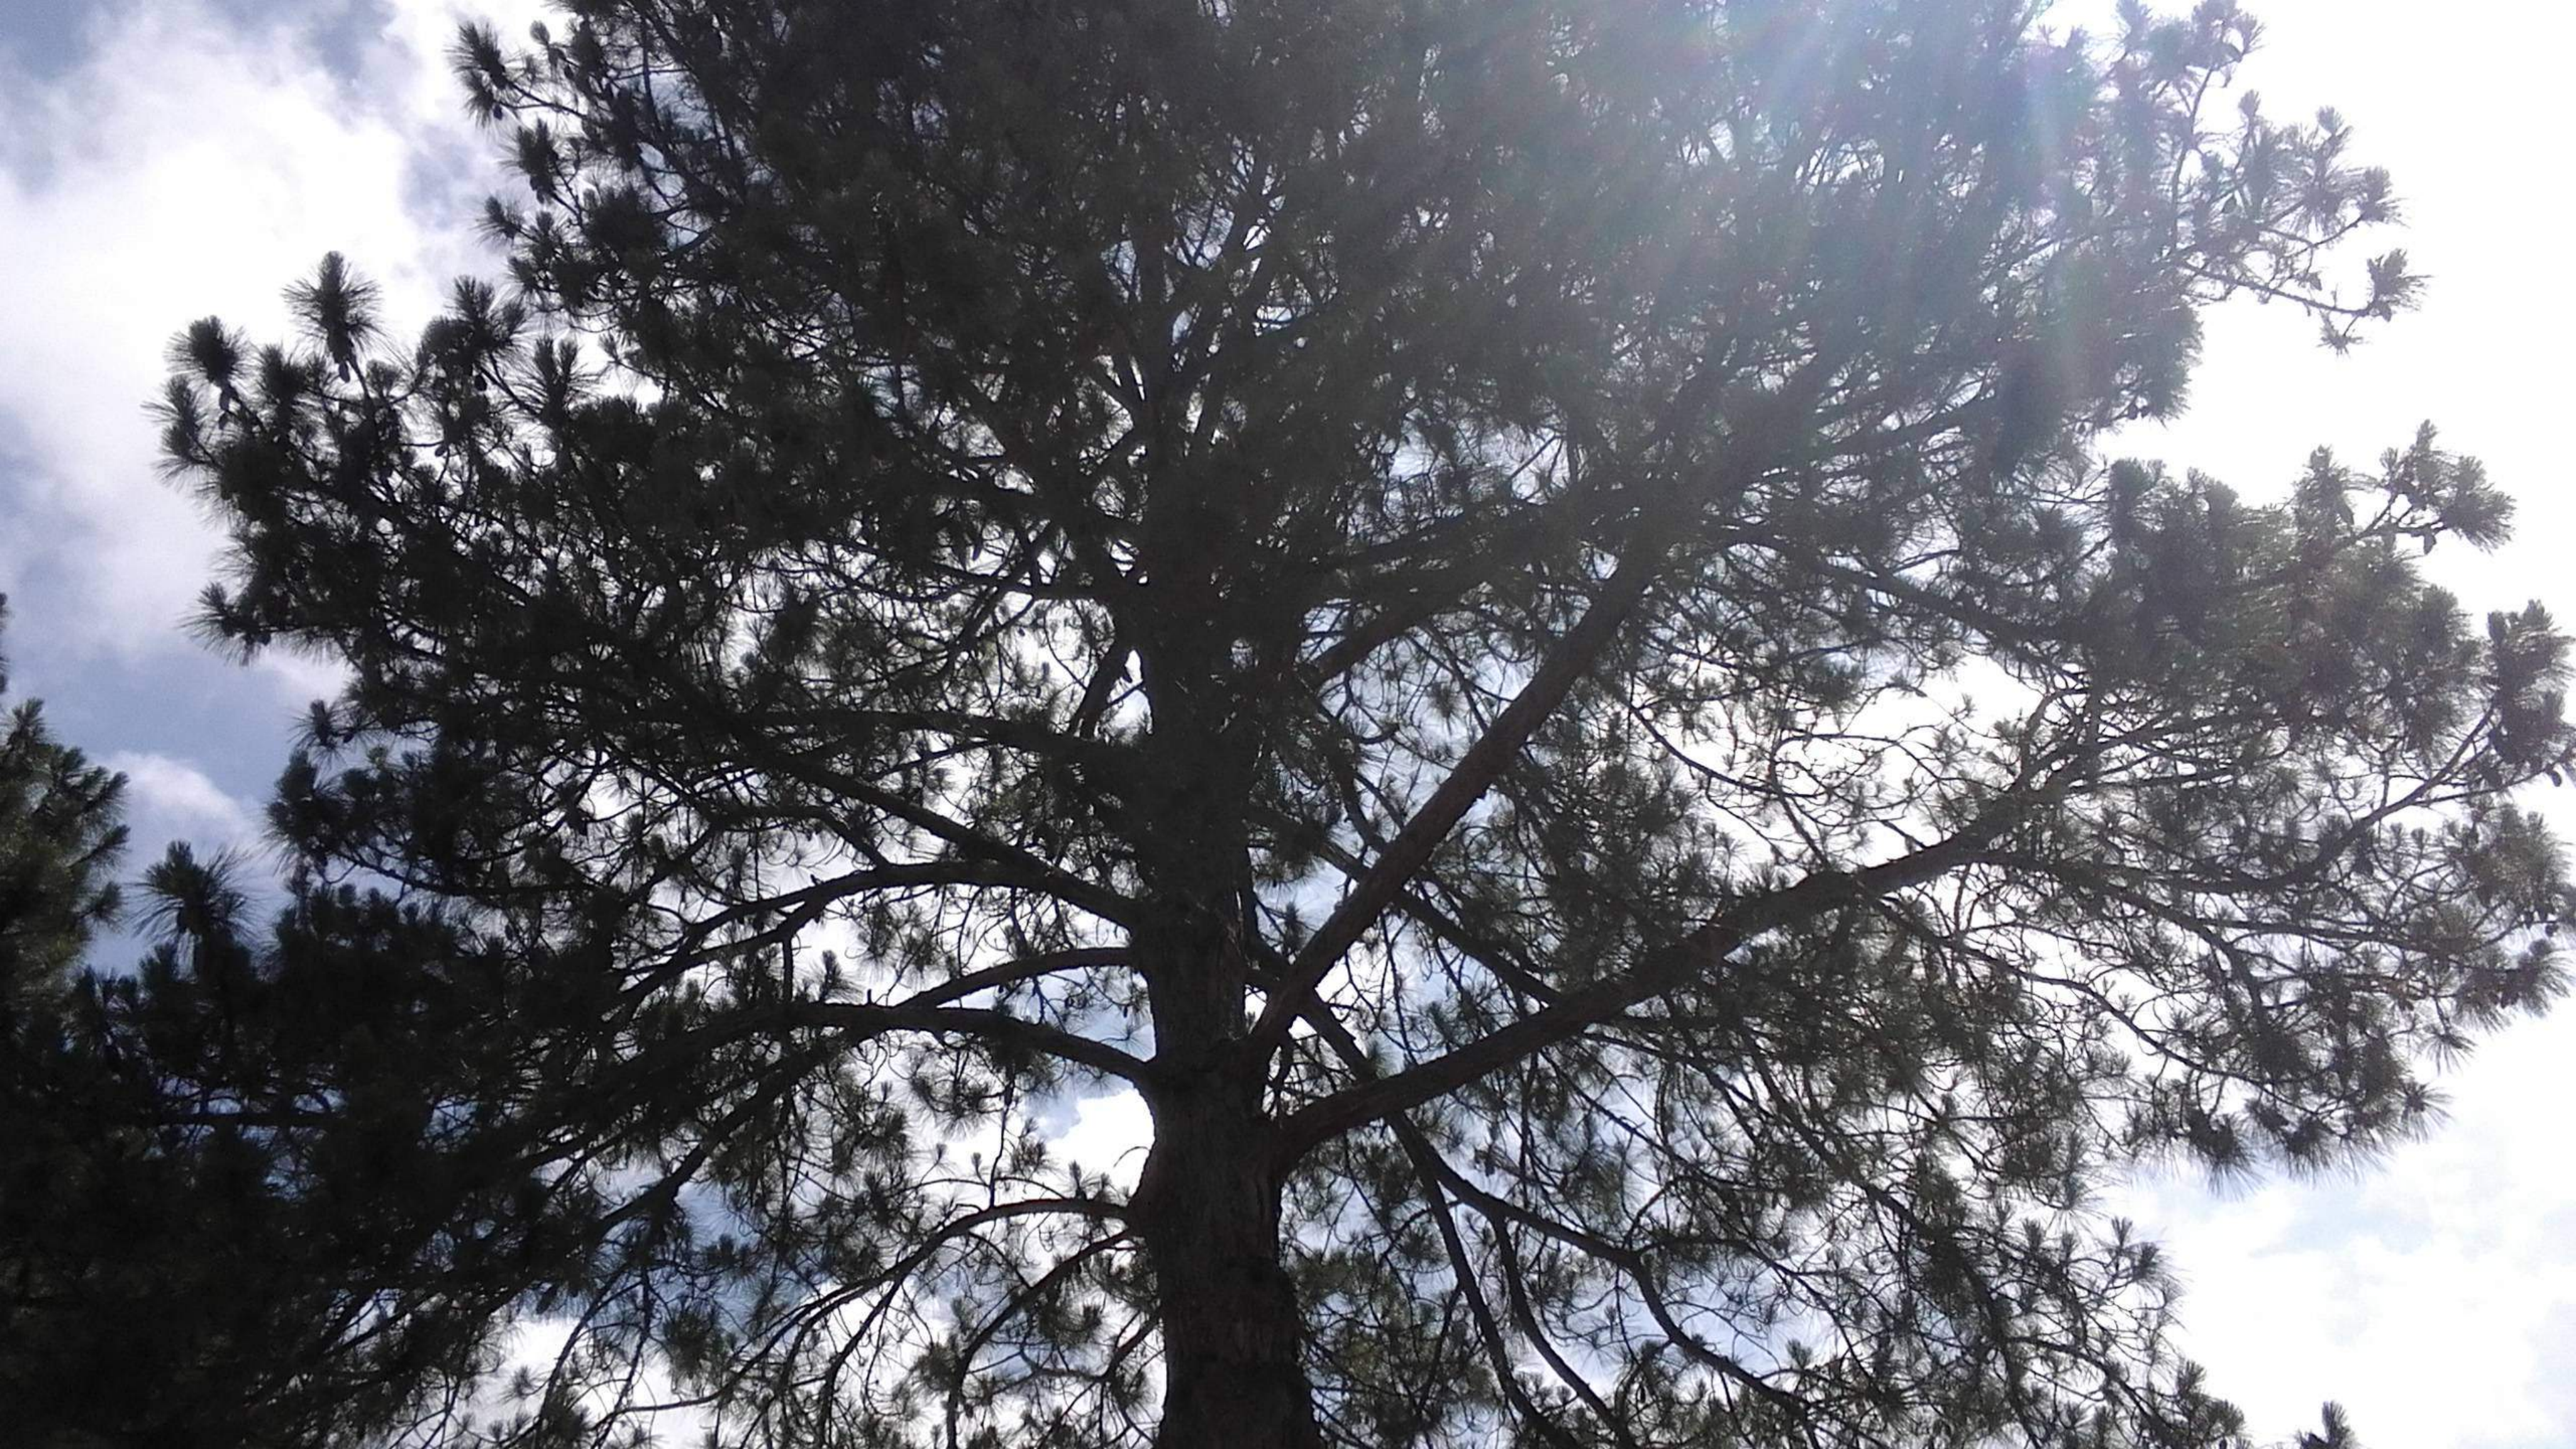
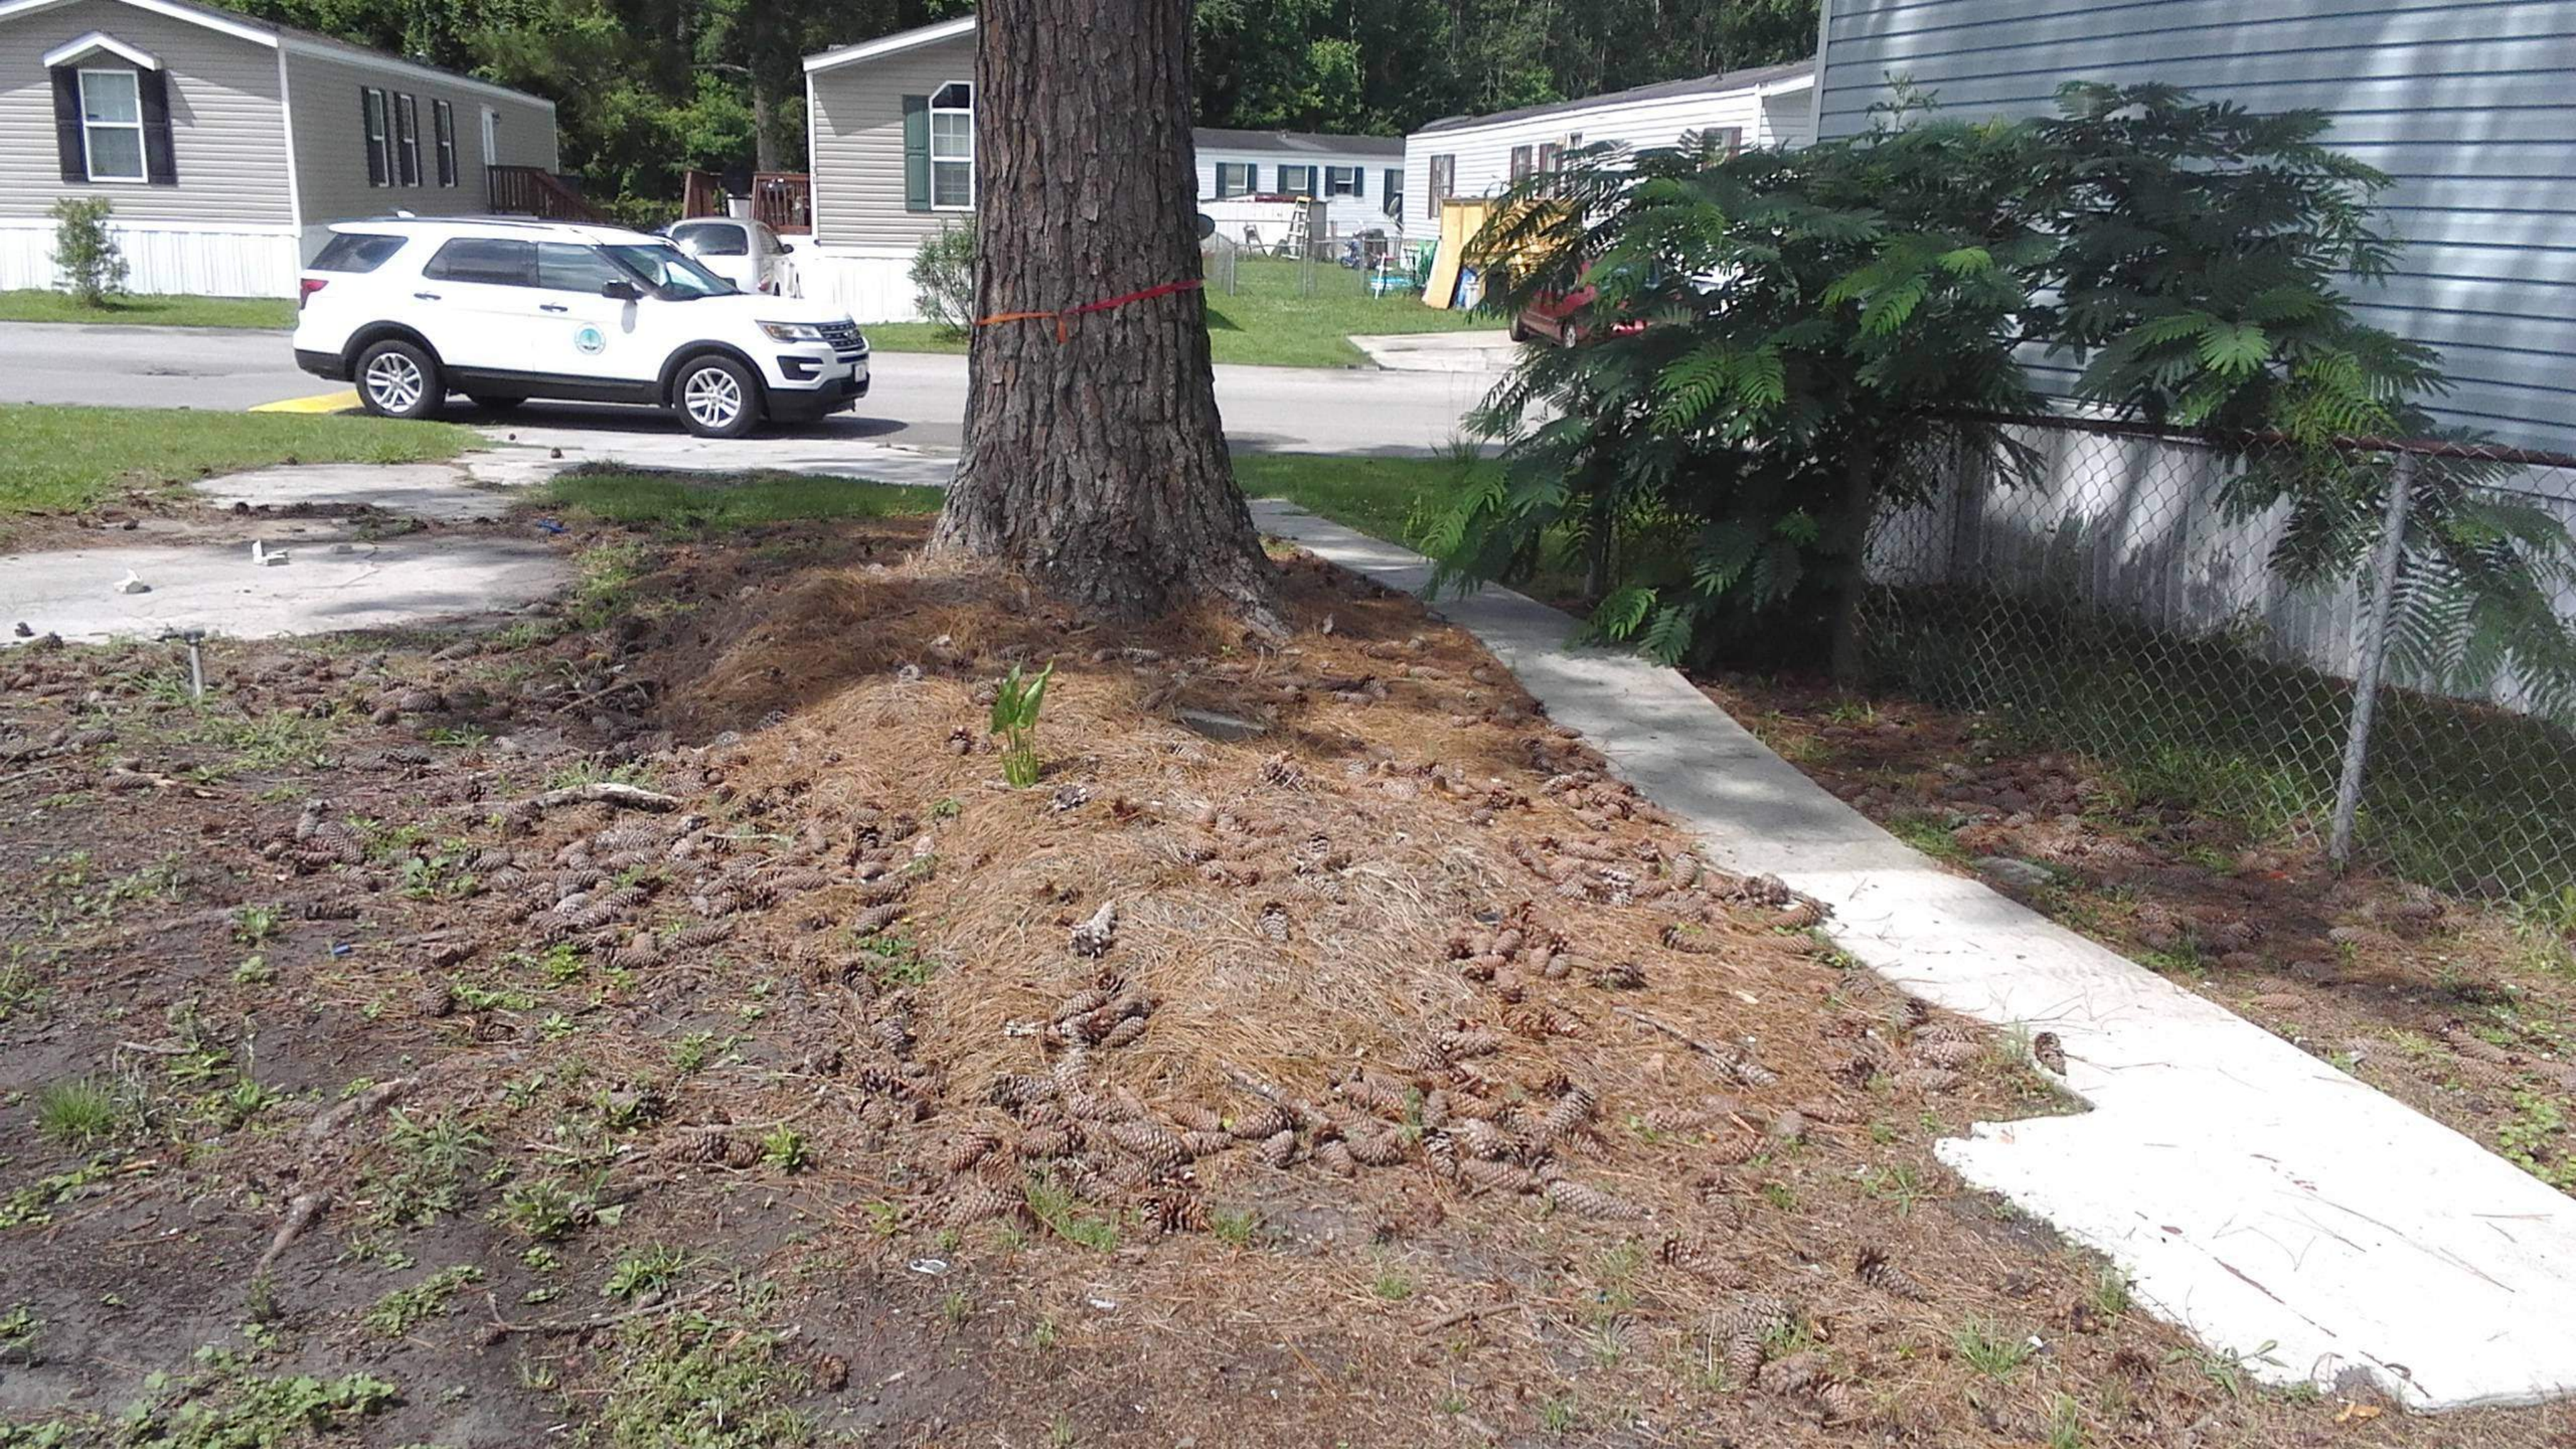
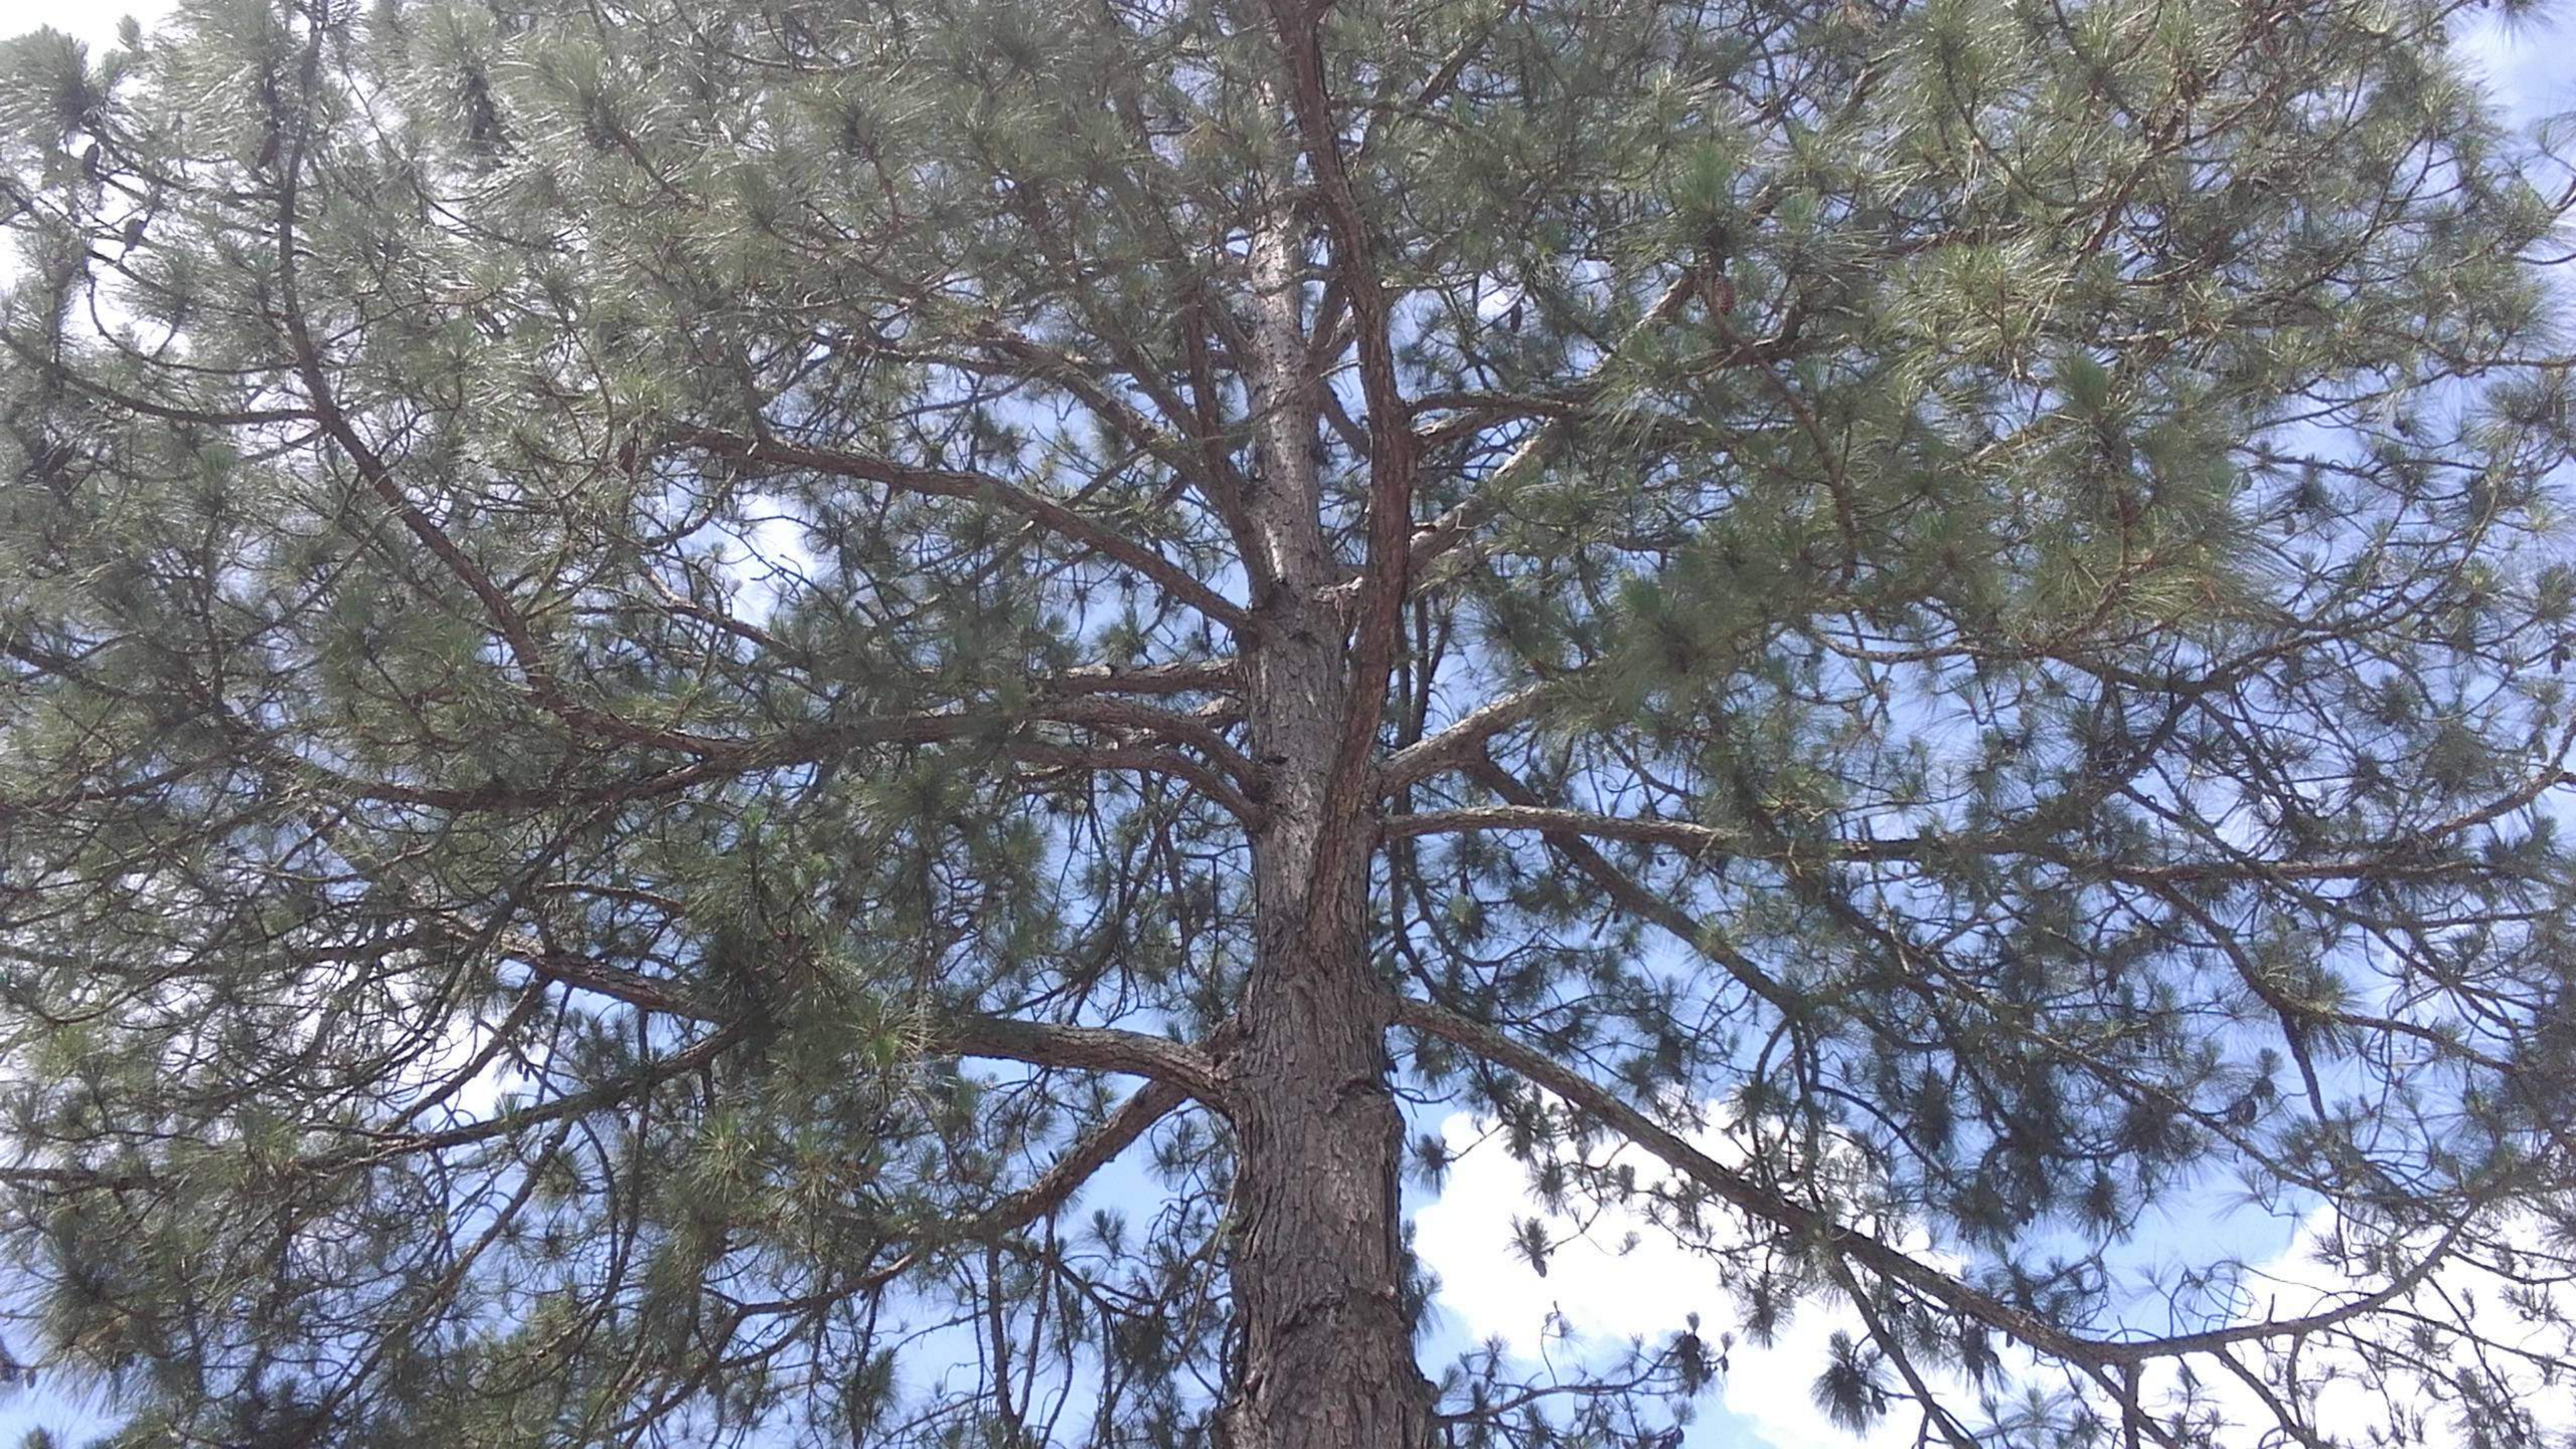
1925 Bacons Bridge Rd
1123 Berestford Ln.

Evaluation: The pine tree is in good condition.

Overall tree risk rating Low ☒ Moderate ☐ High ☐ Extreme ☐Overall residual risk None ☐ Low ☒ Moderate ☐ High ☐ Extreme ☐ Recommended inspection interval 1 yearData ☒ Final ☐ Preliminary Advanced assessment needed ☐ No ☐ Yes-Type/Reason _____Inspection limitations ☒ None ☐ Visibility ☐ Access ☐ Vines ☐ Root collar buried Describe _____
